# Investigation of the renewable diseases in the Maiji Grottoes: some reflection for PVAc

**Keywords:** Maiji Grottoes; murals; PVAc; renewed disease

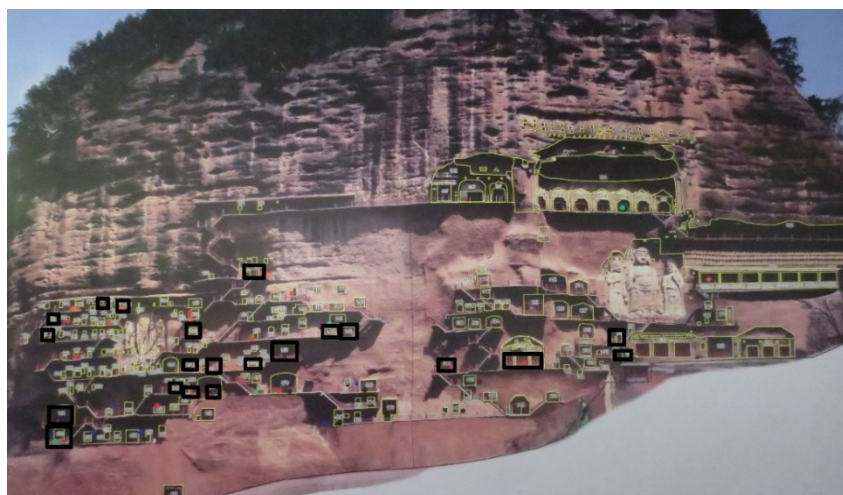
The Maiji Mountain locates in the rain forest area. According to the meteorological statistics since 1970s, the annual sunlight is about 1200 to 1600 hours, the mean annual precipitation and evaporation capacity is about 840 ml and 1000 ml, the relative humidity is 74% and the extreme maximum and minimum temperature are 32.5 °C and -16.8 °C (on July 20, 1997 and January 15, 1992, respectively). Under this environment, the grottoes which locate at the bottom and top of the mountain are much different in the micro-climate. Thus in this investigation the grottoes located at the top and middle of the mountain were chosen to study the renewed diseases over time (the surveyed areas were about 137.72 m<sup>2</sup>, covering above 14% mural areas in the Maiji Grottoes). And the grottoes located at the bottom of mountain as control groups to study on the influence of humidity on renewed diseases after reinforcement by PVAc emulsion (fig 2).

Figure 2 the whole picture of maiji mountain grottoes and the surveyed caves in this work (marked with black box)

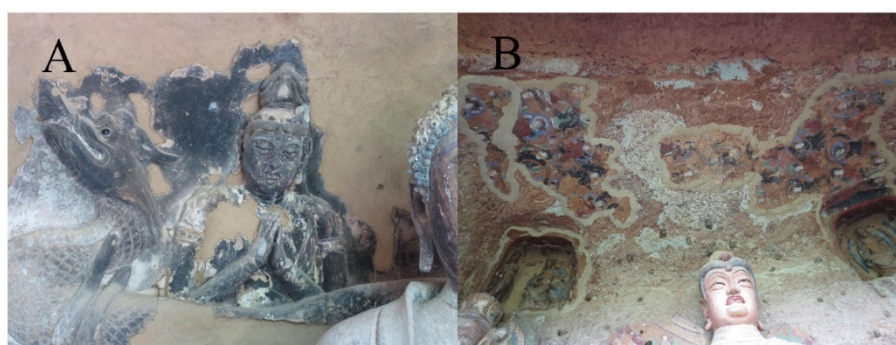
Figure 3 Different repair crafts between the works made in the 1980s and the 2000s (A. repaired in the 1980s and B. repaired in the 2000s)

The investigation result was listed in table 1. Overall, the renewed diseases occupied 6.43%, 5.76%, 5.77% and 0.43% of the recovered areas in each decade (the 1970s, the 1980s, the 1990s and the 2000s, respectively). The area proportions of renewed diseases in the first 3 decades (from the 1970s to the 1990s) were similar. This means the protective effect of PVAc almost had no change during this long period. And the renewed diseases occurred seemed to have had little relation with time. On the contrary, there were little renewed diseases in the murals repaired after 2000. This unusual difference might be caused by different repair crafts. The traditional edge strengthening, recovering or imitating the base layer of murals no longer appeared in the murals repaired after 2000 (fig 3).

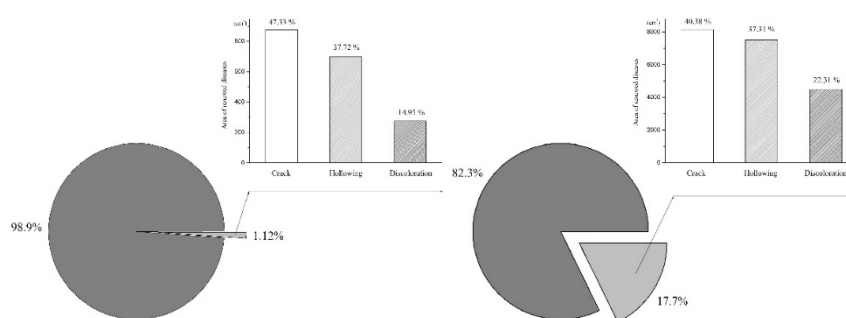
Figure 4 the renewed diseases caused by sunshine in grotto 43<sup>rd</sup> (left) and 44<sup>th</sup> (right)

The results showed the area of renewed diseases accounted for 1.12% of the repaired area in grotto 43<sup>rd</sup>, while this figure reached 17.74% in grotto 44<sup>th</sup> and it was much higher than the average (6.43%). The types of renewed diseases in the two grottos were the same (cracking, discoloration and hollowing) (fig 5) and the ratios of these diseases were also similar. According to the above analysis, sunlight had much relation with the renewed diseases after the murals had been recovered by PVAc. This might due to the decomposition of PVAc under direct sunlight to which PVAc has low resistance [12-13]. Different restoring techniques might also cause the difference in the severity of cracking between the grottoes, since record showed that these two grottoes were repaired by different craftsmen in the same period.

The biggest affect of sunlight on repaired murals is cracking. In this investigation the grottoes 43<sup>rd</sup> and 44<sup>th</sup> are sister grottoes. Factors such as repair time, location and circumstance are almost the same except for sunlight. The sunlight shines directly on grotto 44<sup>th</sup> (the sunshine duration may reach above 7 hours per day in summer) while grotto 43<sup>rd</sup> is barely shined. The statistical results are as follows (fig 4).

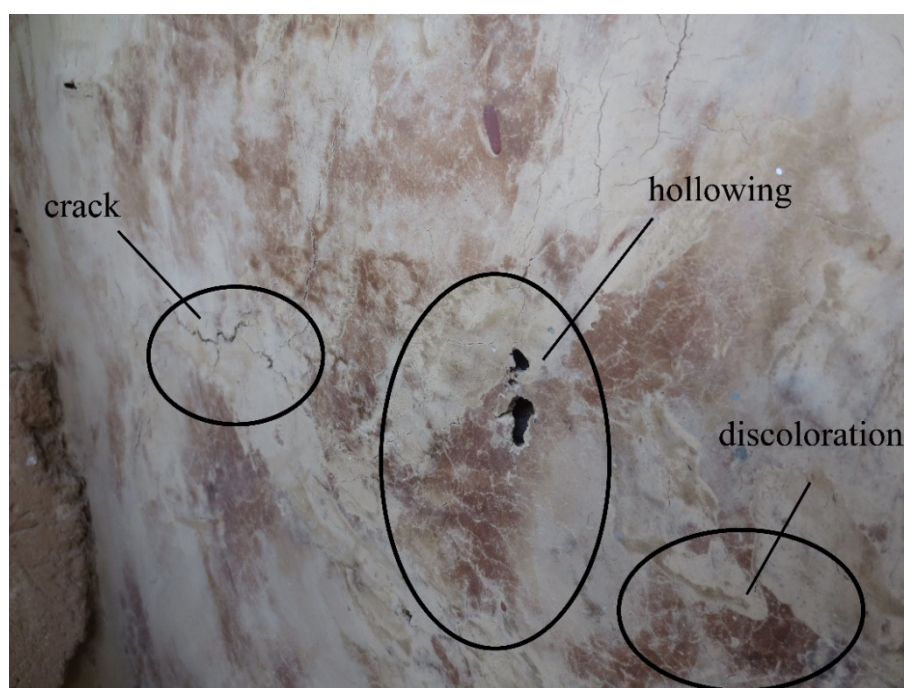
Figure 5 the picture of renewed diseases at the repaired area in the 44<sup>th</sup> grotto

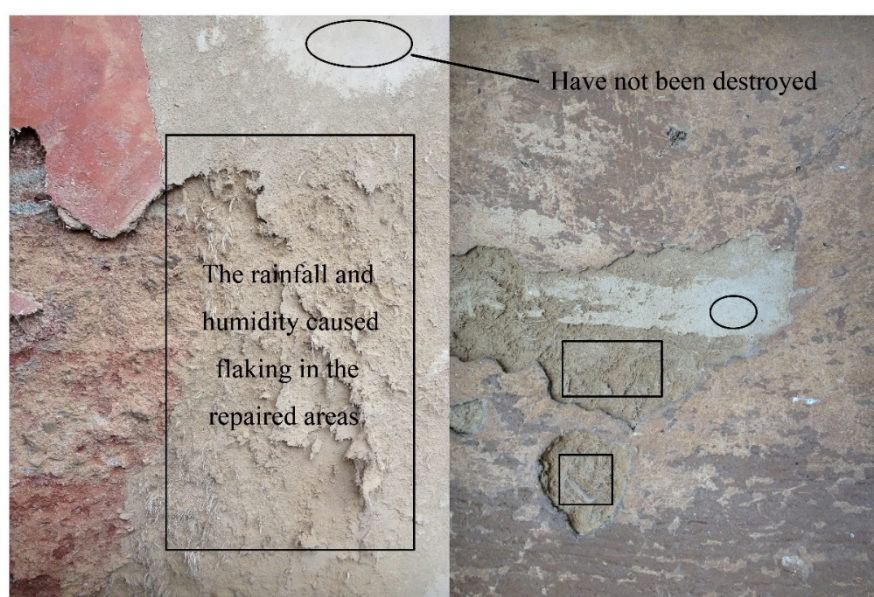
The areas of renewed diseases in grottoes 191 and 59 accounted for 26.89% and 16.04% of recovered areas, respectively. Among them a new disease (fig 6) which caused by humidity was very universal. The areas of saline-alkaline and flaking accounted for 16.34% and 3.29% of recovered areas in grotto 191<sup>st</sup> and 59<sup>th</sup>. Previous research [4] found that PVAc had low water resistance due to its carboxyl and hydroxyl groups. Rain washing and water penetration of cliff body also lead to the burst of the new disease in these two grottoes. Thus, the PVAc was not an ideal repairing material under a humid circumstance according to this investigation.

Figure 6 rainfall and humidity caused the repaired materials flaking  
(left is the 191<sup>st</sup> grotto and right is the 59<sup>th</sup> grotto)

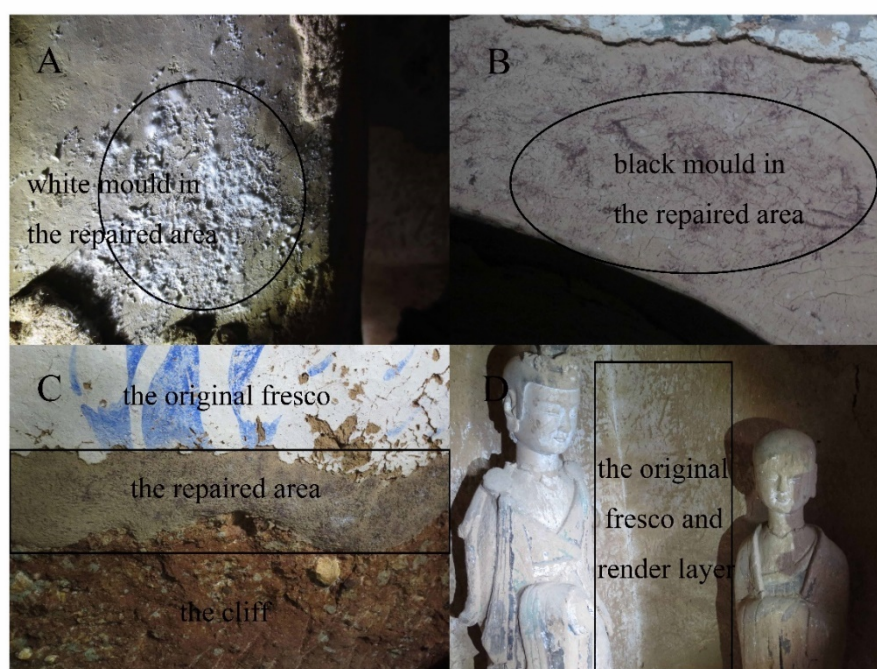
Enclosed environment is another factor which would probably result in diseases. In the investigation we found that much repaired area mildewed in the 123<sup>rd</sup> grotto

and the 135<sup>th</sup> grottoes (fig 7), which was hardly found in other grottoes from the same height. The only difference might be that the 123<sup>rd</sup> and the 135<sup>th</sup> grottoes were always closed. Therefore, the microenvironment (humidity and temperature) of these two grottoes remained steady and created a good condition for microbial growth. However, no mould was found on the surface of the original fresco and the render layer (fig 7C and D). This indicated that the necessary nutrient offered by PVAc might favor the microbial growth.

Compared with other polymer (like acrylic resins) used in heritage conservation, PVAc is easily attacked by biological agents [14-15]. Francesca et al. [14] noted the PVAc is more resistant to attacks in a dry environment, while under favourable conditions of temperature and relative humidity, it is likely to be susceptible. This might explain why the mildew concentrated in the 123<sup>rd</sup> grotto and 135<sup>th</sup> grottoes. Moreover, some researches [14-16] reported that impurities and additives in commercial PVAc such would also make it more vulnerable to fungi. Given the long years (several decades) of repairing work in the Maiji Grottoes, the PVAc used in restoration might have been purchased from different companies, but this conjecture couldn't be confirmed for now. But on the whole, the specific conditions in these two grottoes likely played an important role in causing this renewed disease.

Figure 7 the white and black moulds grow on the surface of repaired areas  
(A and B: the 123<sup>rd</sup> grotto; C and D: the 135<sup>th</sup> grotto)
