# The Application of Lubricating Oil Particle Size Analysis Technology in the Condition of CSP Line High-pressure Hydraulic System Pump Failure

Valin Lianyuan Iron and Steel Co, Ltd, Loudi, 417000, Hunan, China

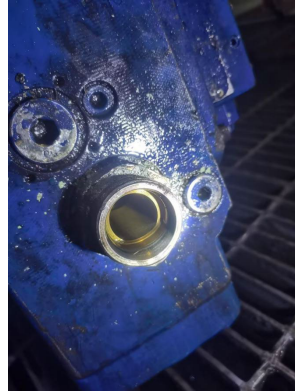
After data analysis and on-site investigation, as expected, fine copper powder was detected in the oil inlet pipe of the high-pressure hydraulic system's oil pump, and a small amount of copper powder was also found in the overflow pipe. There were also fine copper powder distributions inside the pump casing. There is wear and pitting on the oil distribution plate and plunger slide shoe. The filtering effect of the filter element at the outlet of the high-pressure oil pump is not ideal, resulting in copper powder particles smaller than  $10\text{ }\mu\text{m}$  infiltrating the hydraulic system pipeline, thereby blocking the  $3\text{ }\mu\text{m}$  filter element of the servo valve pilot stage, causing instability in the control oil circuit, and ultimately causing the servo valve to adhere and trigger an alarm, becoming the direct cause of the accident. As is show in Figure 1, Figure 2 and Figure 3.

*Figure 1 Pump Overflow Pipe*

On site technicians immediately organized the replacement of servo valves, and at the same time, replaced all oil pump outlet filter elements and faulty valve control oil filter elements in the hydraulic

station (a total of 13 hydraulic valves and 15 filter elements were replaced). 17: 43 points, production resumed after zero adjustment simulation of the rolling mill.

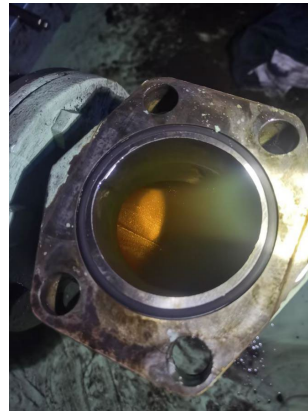
*Figure 2 Bottom of Pump Inlet Pipe*

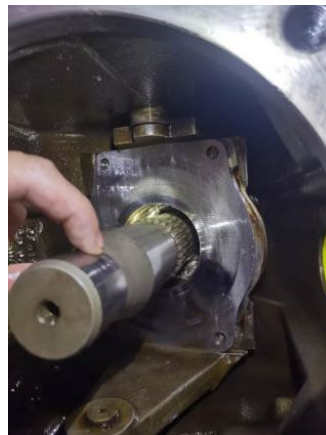
*Figure 3 Inside the pump casing*
